Manhole Inspection Summary

Manhole # S43Y1_007MH

Insp Date: **12/4/07 1:24 PM**

Location Address: **900 E Patapsco Ave**

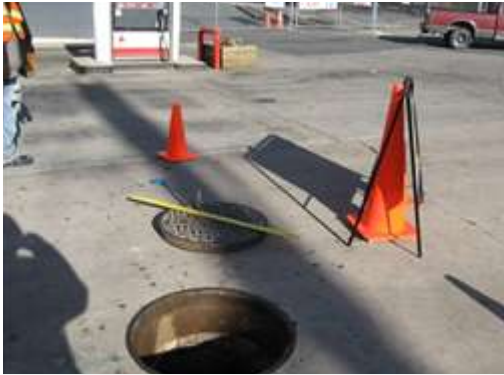
Location View

citgo station on E Patapsco & 9th street

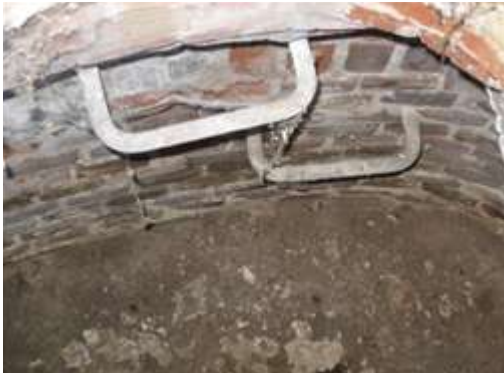
steps

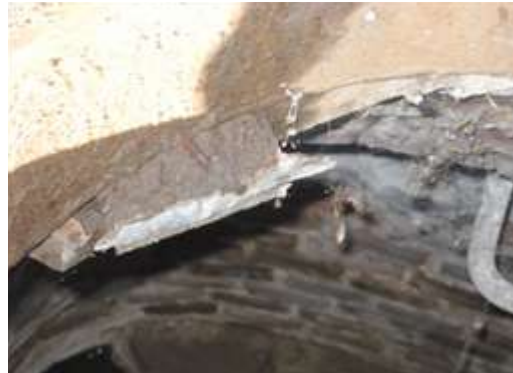
Defect 1

Condition: ☐ Sound ☐ Cracked ☐ Root Intrusion ☒ **Loose Brick** ☐ Deteriorated

loose bricks on chimney

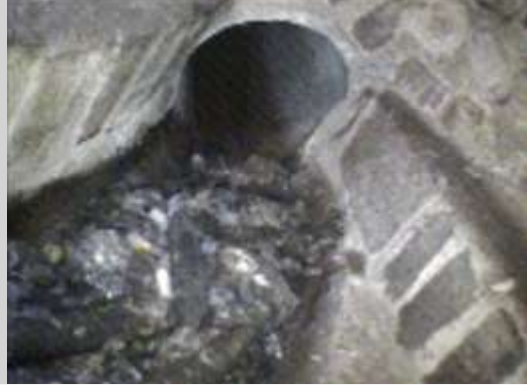
12 O'Clock Outflow

8 in. Circular Gravity Sewer
Pipe Out @ 12 O'Clock

Pipe Height: **3.6** (in.) Rod and Bar (Angled)
Pipe Material: **Clay** ☐ Pipe Lined
Invert Depth: **1.00** (ft.) Flow Characteristics: **None**
Deposits: ☒ None ☐ Mud ☐ Sludge ☐ Debris ☐ Grease
Silt Depth: (in.) Deposits Extent:
Infiltration: **None** Pipe Seal Cond: **Sound**

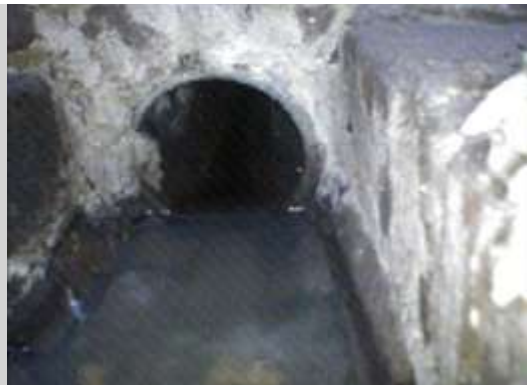
6 O'Clock Inflow

8 in. Circular Gravity Sewer
Pipe In @ 6 O'Clock

Pipe Height: **7.2** (in.) Rod and Bar (Angled)
Pipe Material: **Clay** ☐ Pipe Lined
Invert Depth: **6.30** (ft.) Flow Characteristics: **None**
Deposits: ☒ None ☐ Mud ☐ Sludge ☐ Debris ☐ Grease
Silt Depth: (in.) Deposits Extent:
Infiltration: **None** Pipe Seal Cond: **Sound**
